BOLIGBRANN

REPORT NO./DNV REG No.: / 13XKQRR-1  
REV , 2012-01-05

Summary:  
 This report covers testing of a hose to be used in case of house fire. The hose was supplied by Gowens engros.

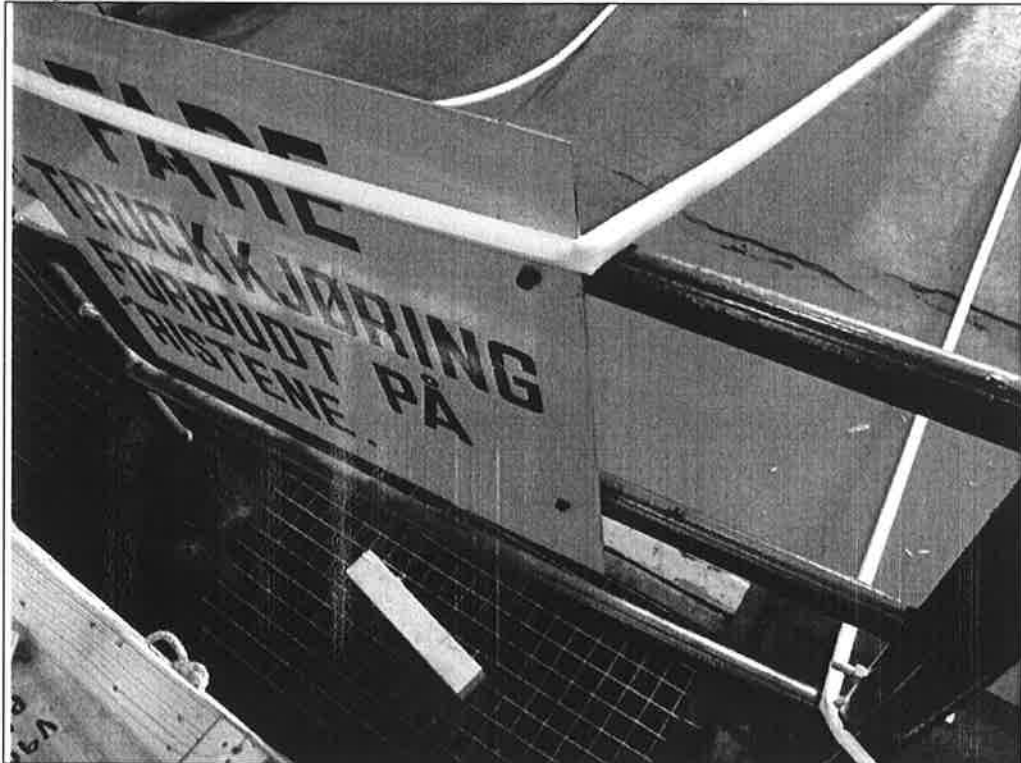
**Figure 6-6:** 1:st and 5:th bend.
